INSTRUMENTATION APPENDIX TO
PERIODIC INSPECTION REPORT NO. 5
WESTVILLE LAKE DAM
SOUTHBRIDGE/STURBRIDGE, MASSACHUSETTS

March 5, 1996

Department of the Army
New England Division
Corps of Engineers

Project 95272

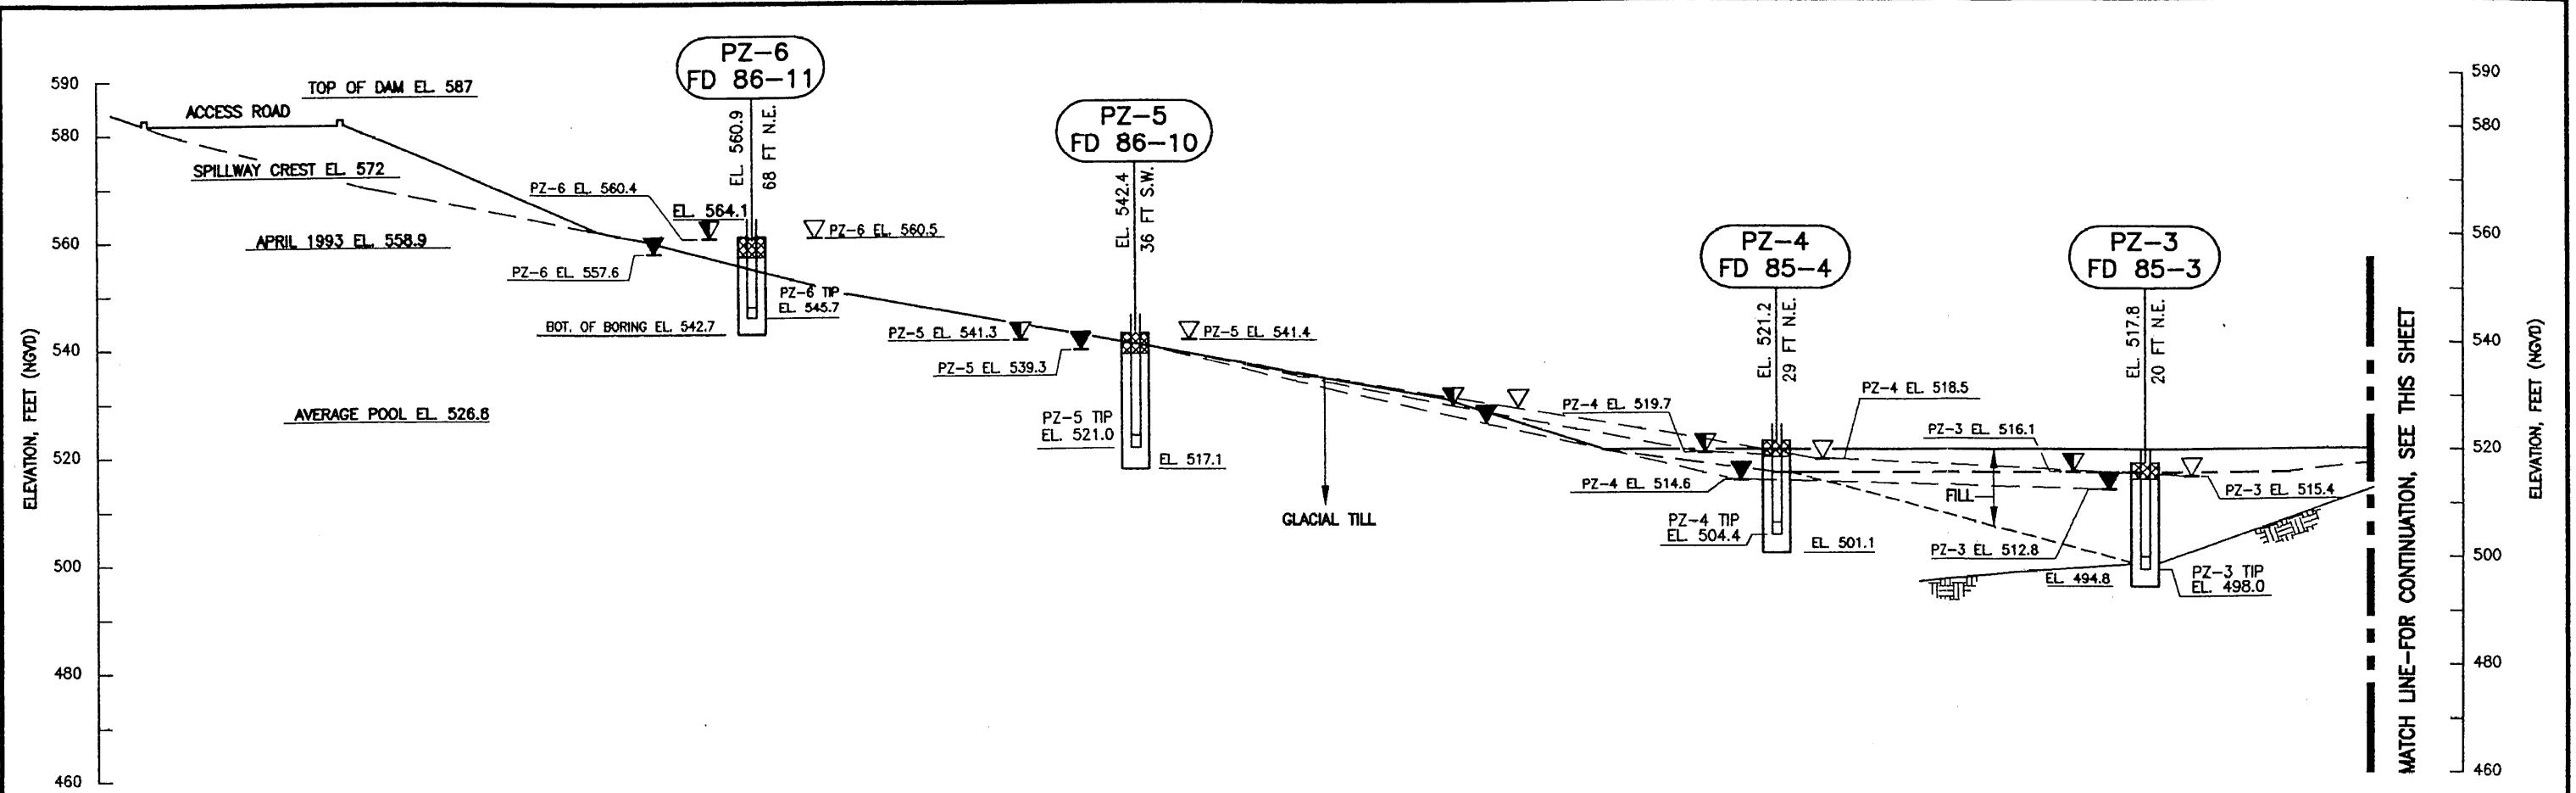
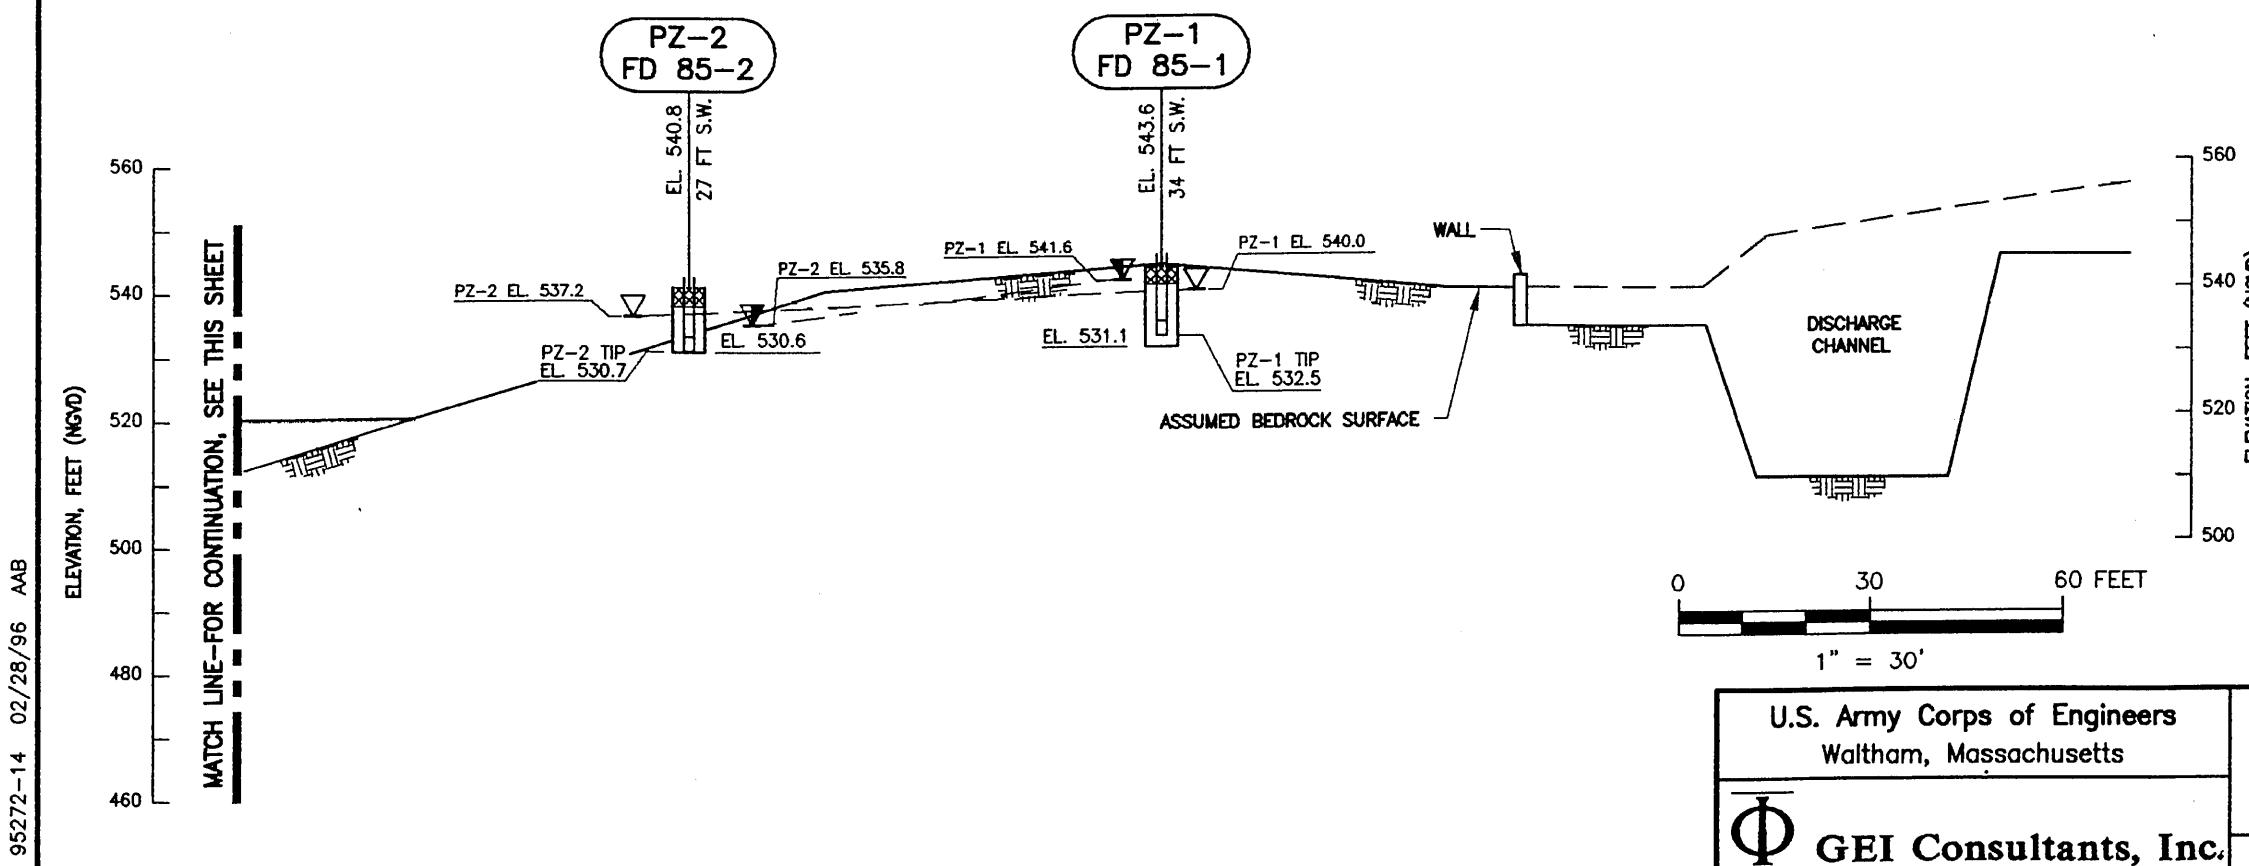
PROFILE B-B WITH
PIEZOMETER PORE
WATER LEVELS
February 1996 Plate 14

The pore water levels shown in Plate 15 and inferred phreatic surfaces show a steep gradient across the impervious fill core of the dam. This drop in pore water levels across the core of the dam indicates that the combination of embankment impervious fill core, foundation grout curtain, and embankment pervious fill drain provide a relatively effective cutoff of upstream seepage pressures and drainage of downstream seepage pressures.

- NOTES:**
1. SEE PLATE 13 FOR LEGEND
 2. SEE PLATE 3 FOR LOCATION OF SECTION B-B.
 3. POOL LEVELS LESS THAN EL. 535 ARE CONSIDERED NORMAL POOL. THE CALCULATED AVERAGE POOL LEVEL FROM AUGUST 1990 TO AUGUST 1995 IS EL. 526.6
 4. PZ-1 AND PZ-2 ARE NORMALLY DRY.

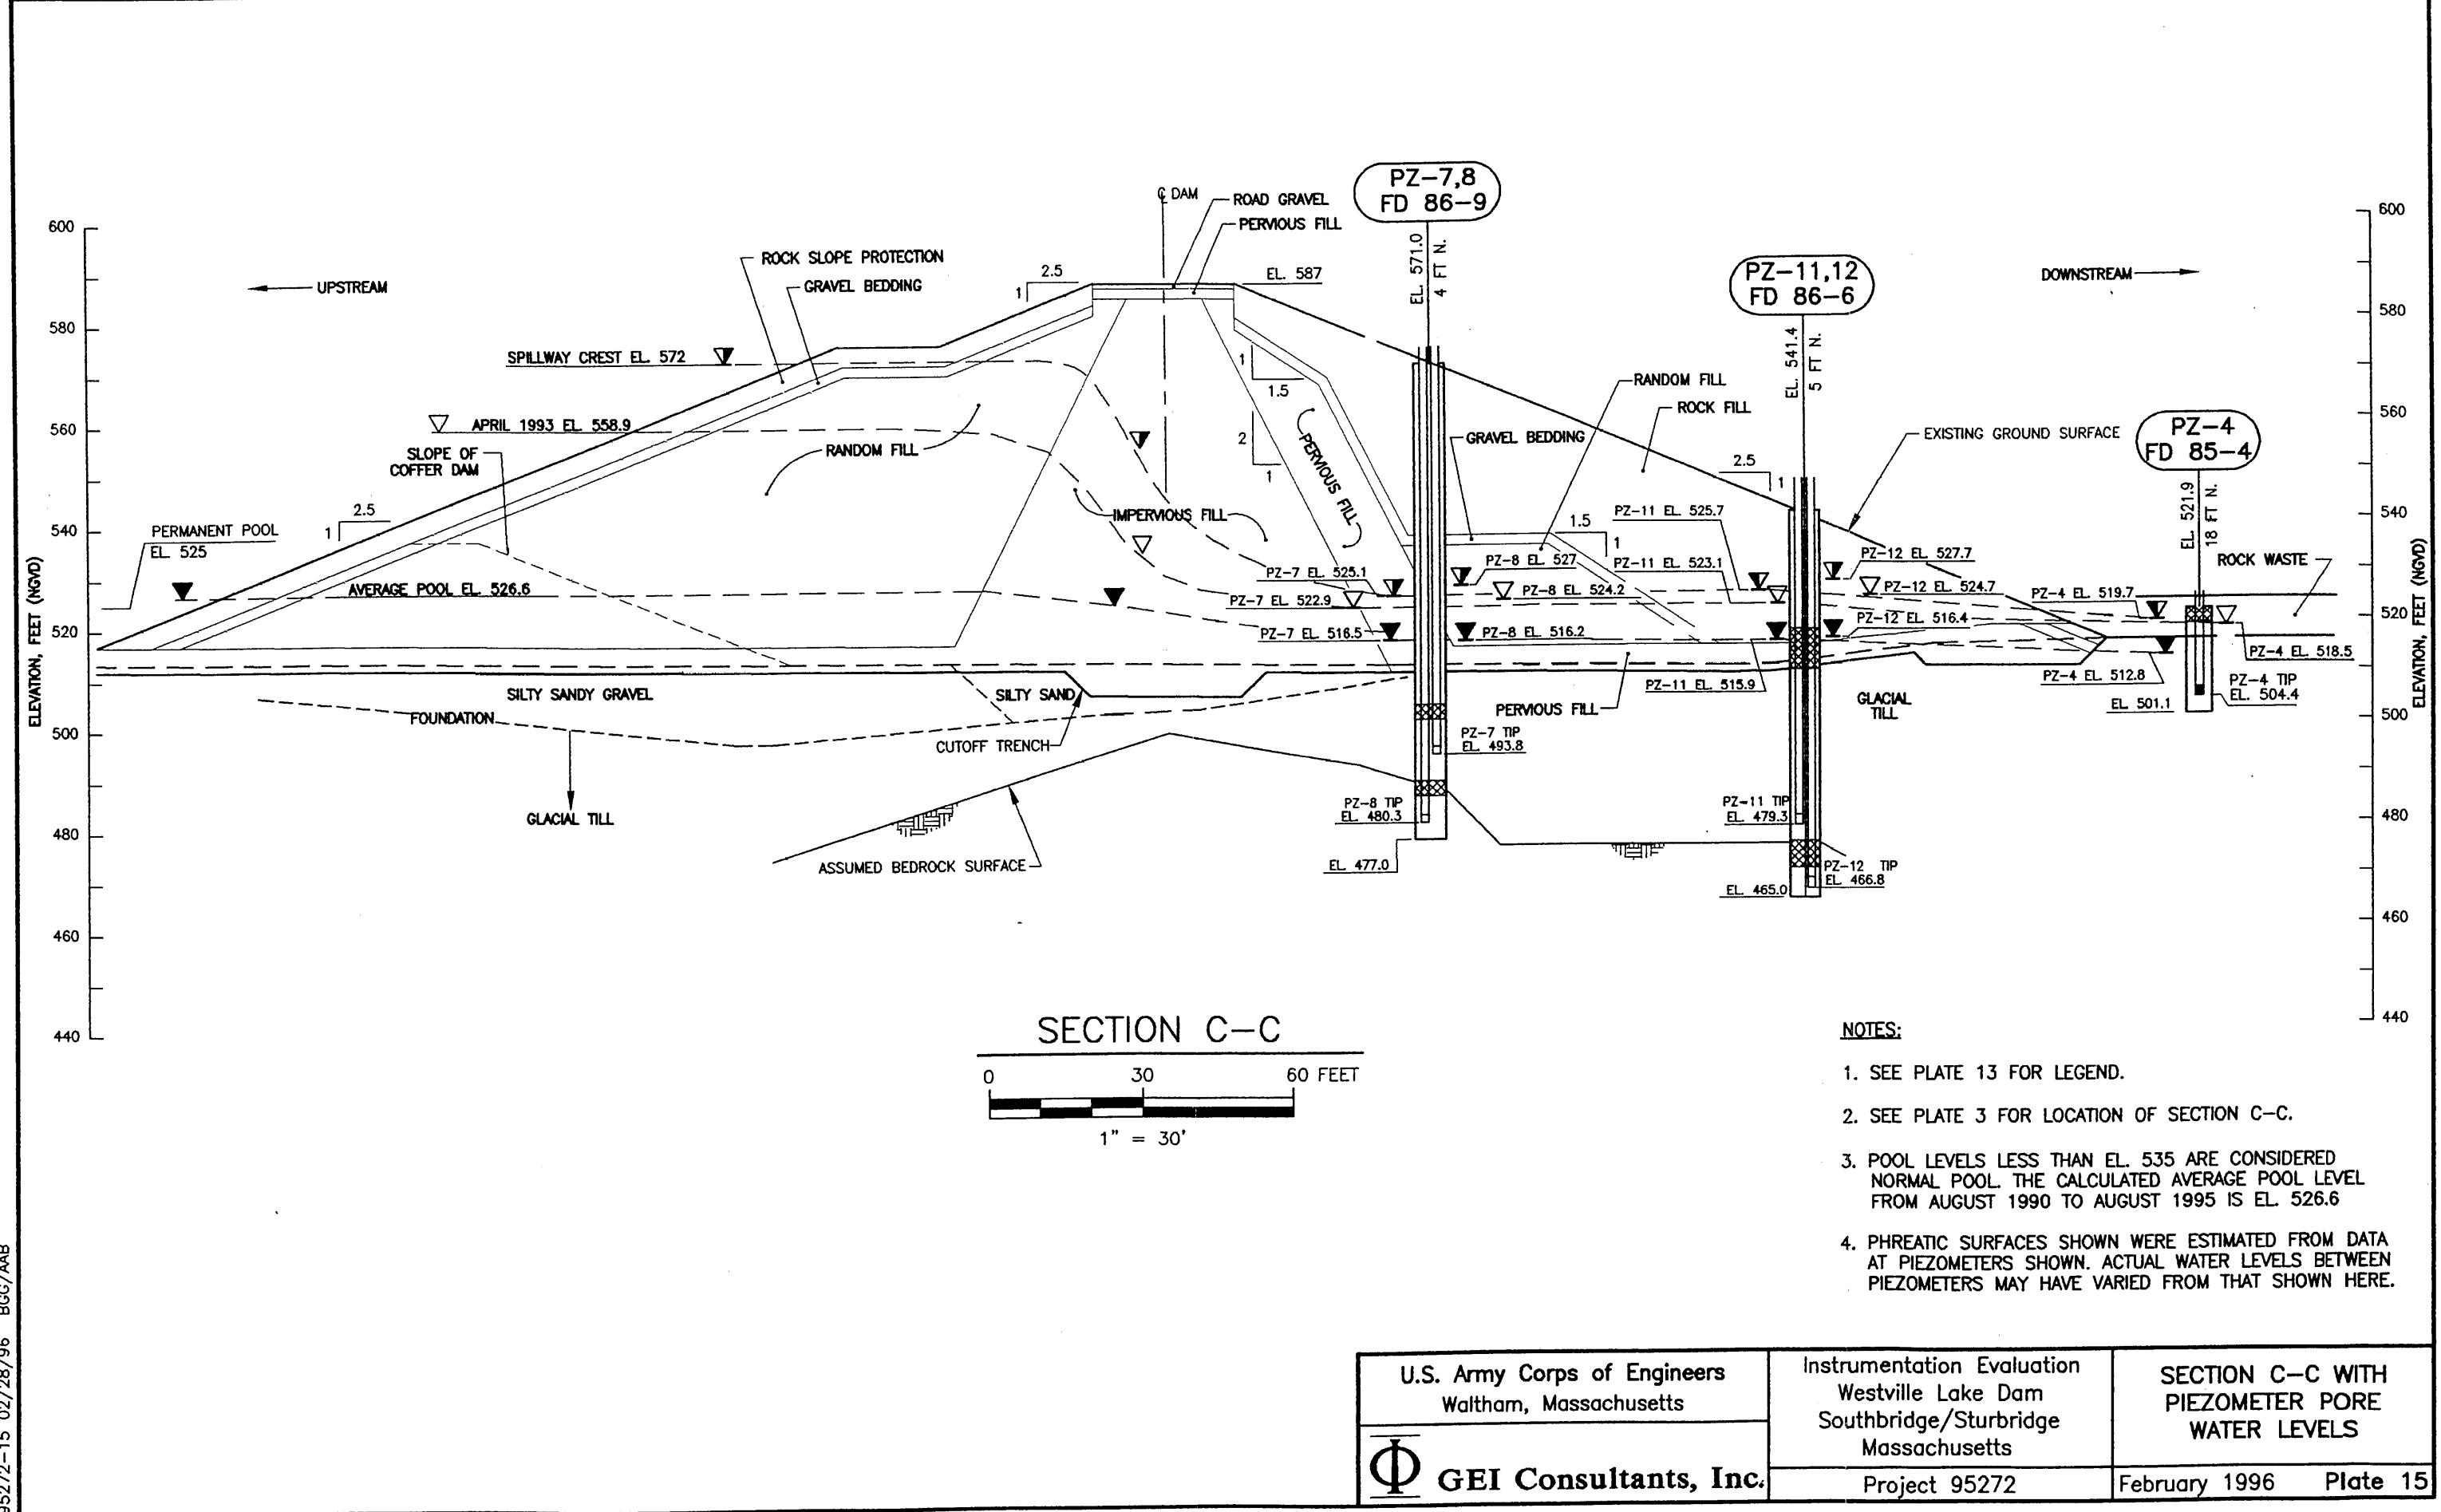
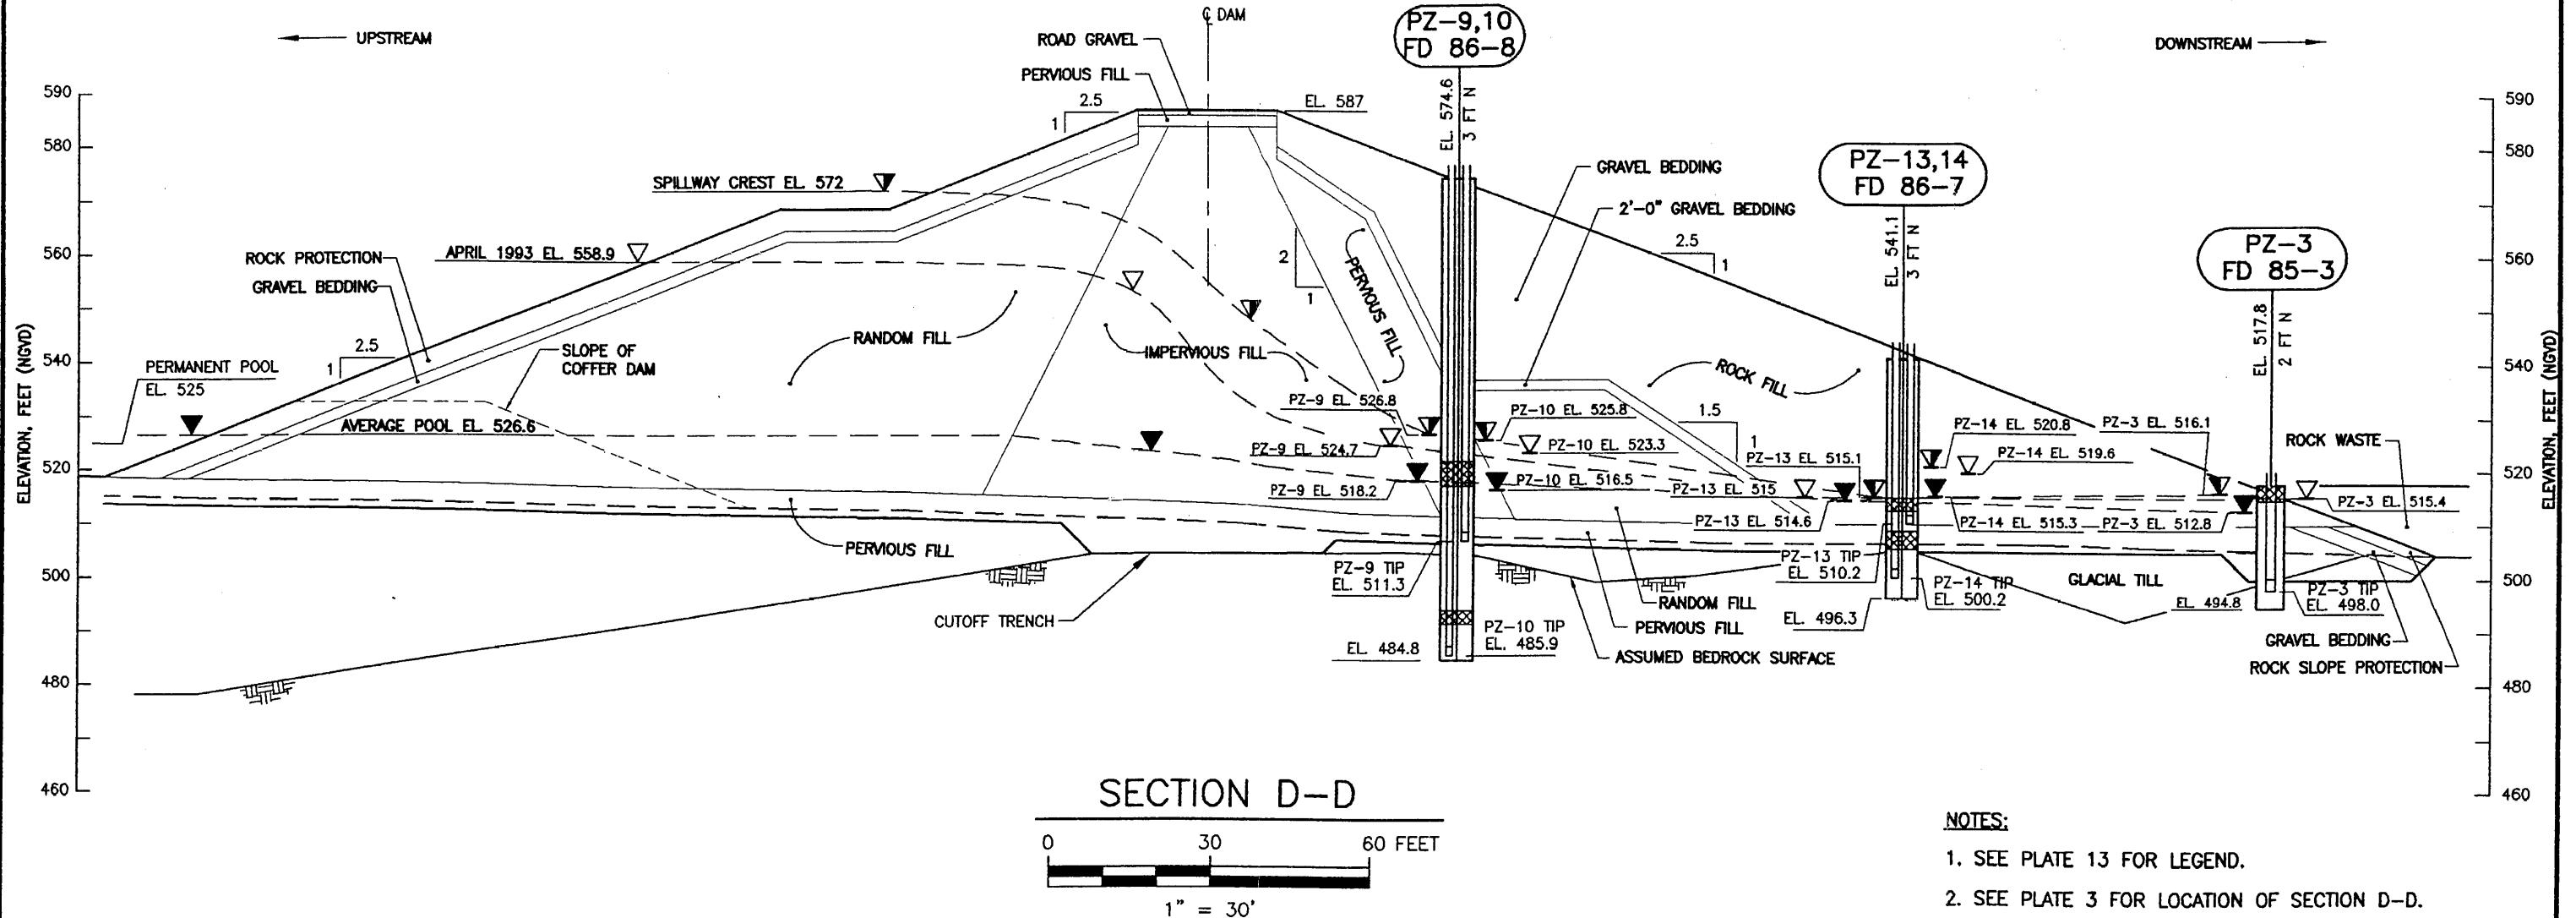
The pore water levels shown in Plate 15 and inferred phreatic surfaces show a steep gradient across the impervious fill core of the dam. This drop in pore water levels across the core of the dam indicates that the combination of embankment impervious fill core, foundation grout curtain, and embankment pervious fill drain provide a relatively effective cutoff of upstream seepage pressures and drainage of downstream seepage pressures.

1. SEE PLATE 13 FOR LEGEND.
2. SEE PLATE 3 FOR LOCATION OF SECTION D-D.
3. POOL LEVELS LESS THAN EL. 535 ARE CONSIDERED NORMAL POOL. THE CALCULATED AVERAGE POOL LEVEL FROM AUGUST 1990 TO AUGUST 1995 IS EL. 526.6
4. PHREATIC SURFACES SHOWN WERE ESTIMATED FROM DATA AT PIEZOMETERS SHOWN. ACTUAL WATER LEVELS BETWEEN PIEZOMETERS MAY HAVE VARIED FROM THAT SHOWN HERE.
